Bare Board Material Performance after Pb-Free Reflow

Abstract:

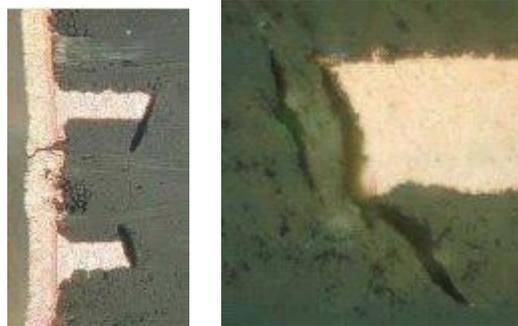
Figure 14

Eyebrow cracks (see Figure 14) were found at the outer periphery of some internal lands. These tend to occur at what appears to be the copper-to-resin interface along most of the vertical portion of the end of the internal land. These often extend for a short distance in a generally diagonal pathway above and/or below the unused land and/or may extend for a short distance along the horizontal interface between the land and the laminate.

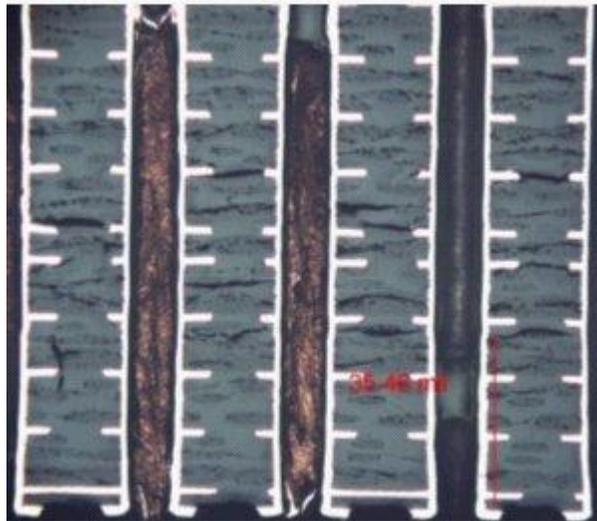
Figure 15

Longitudinal cracks (see Figure 15) extend horizontally (often completely or almost completely) between adjacent vias. These are seen in one or more layers within a given cross-section. These occur within layers that are within the middle third of the stack-up, with a predominance of these being near the center of the stack-up. The majority of cracks include at least some vertical component, sometimes following the sinusoidal pattern of the glass bundles. Besides being at the glass-to-resin interface, these may exist within the resin and/or at the copper-to-resin interface and/or at the core-to-prepreg interface.

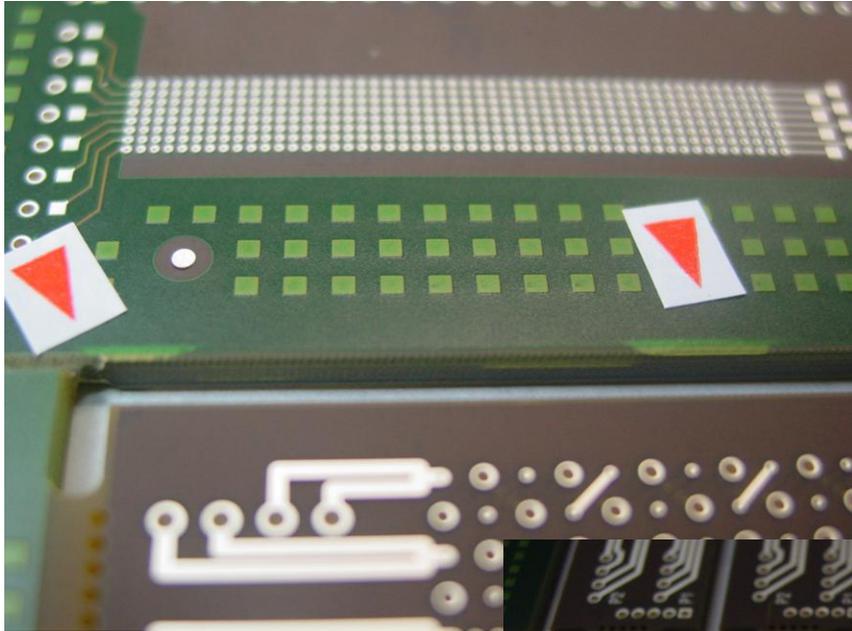
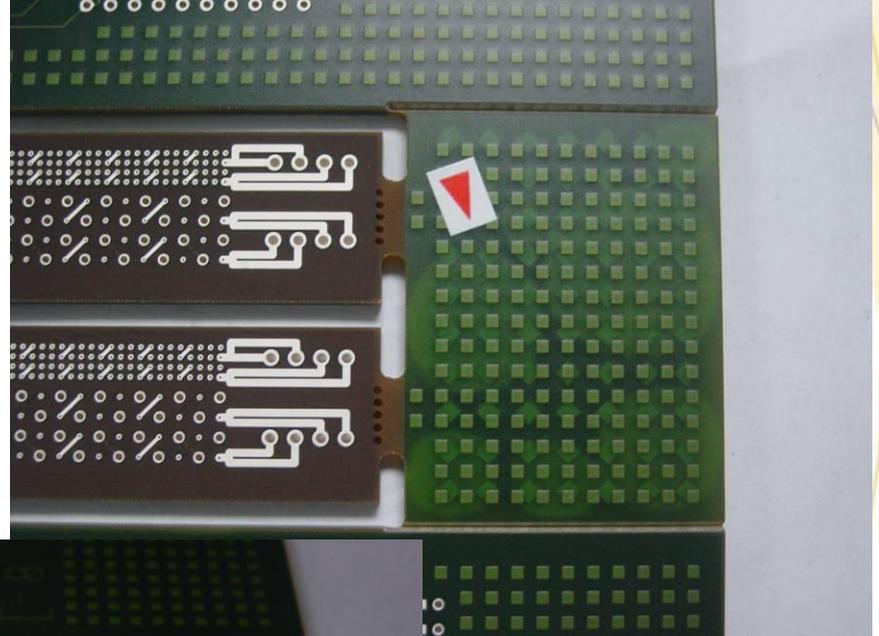
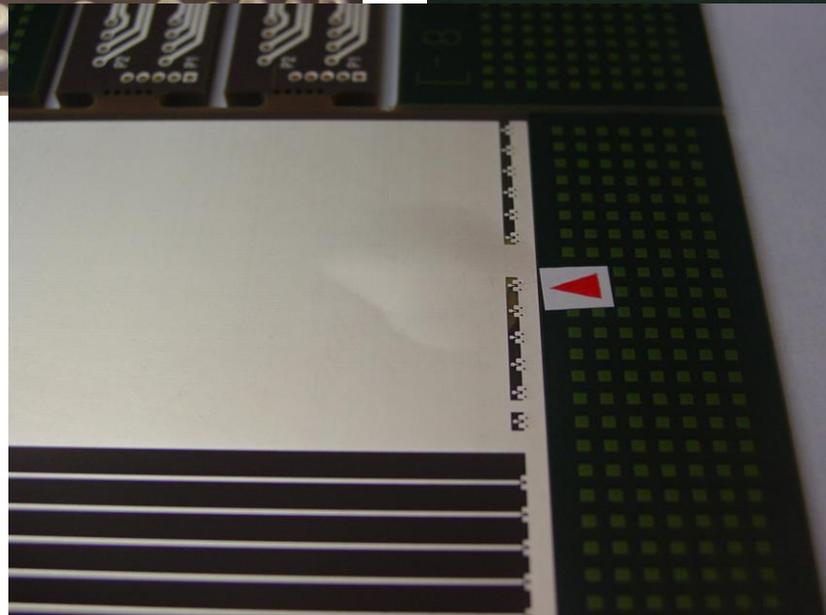
Some Materials showed Visible Defects after Reflow

<i>20 Layer Constructions</i>			
Dash Number	Material	Stackup (A=Low Resin Content, B=High Resin Content)	Results
A	Baseline Non-Filled Phenolic FR4	A	Blistering/delamination after 4X reflow. Minor discoloration
B	Baseline Filled Phenolic FR4	A	No defects
C	Filled Proprietary Resin FR4	A	No defects
D	Filled Phenolic FR4	A	No defects other than incoming
E	Unfilled Phenolic FR4	A	Minor blistering/delamination after 5X reflow
F	Unfilled Phenolic FR4	A	Minor blistering/delamination after 5X reflow
G	Filled Phenolic FR4	A	No defects
H	Unfilled Phenolic FR4	A	Major delamination and blistering after only 2X reflow
I	Filled Phenolic FR4	A	No defects
J	Filled Phenolic FR4	A	Minor blistering/delamination after 3X reflow
K	Unfilled Phenolic FR4	A	No defects
L	Hi-Speed Material	A	No defects
M	Hi-Speed Material	A	No defects
N	Hi-Speed Material	A	No defects other than incoming
P	Unfilled Phenolic FR4	B	Minor blistering/delamination after 6X reflow

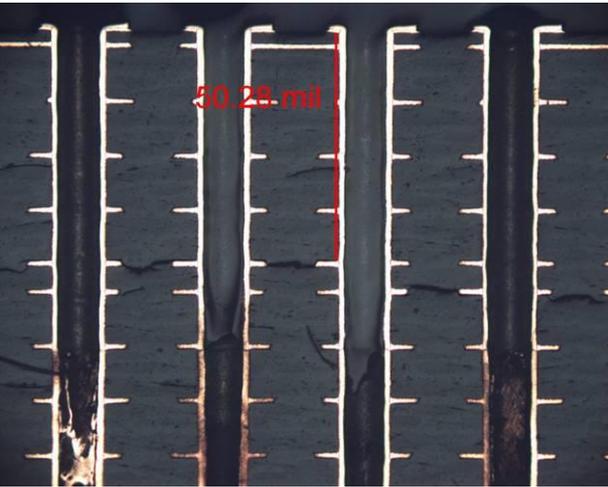
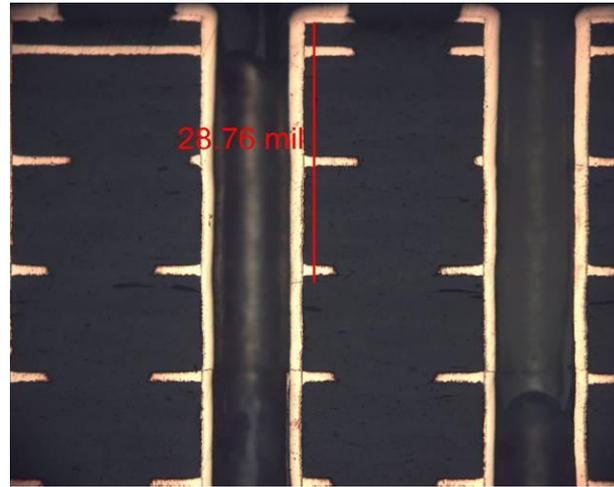
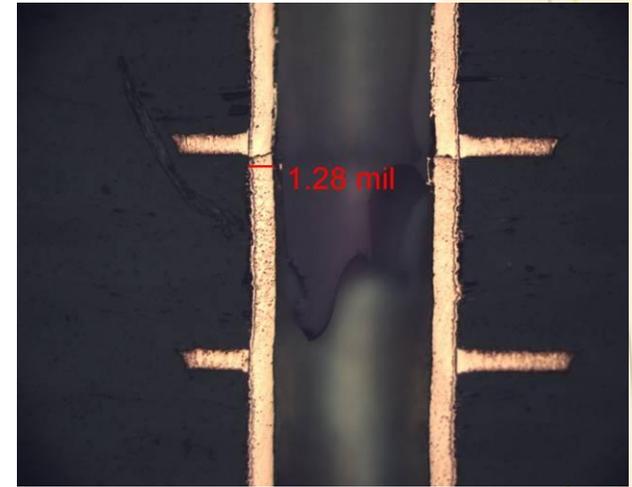
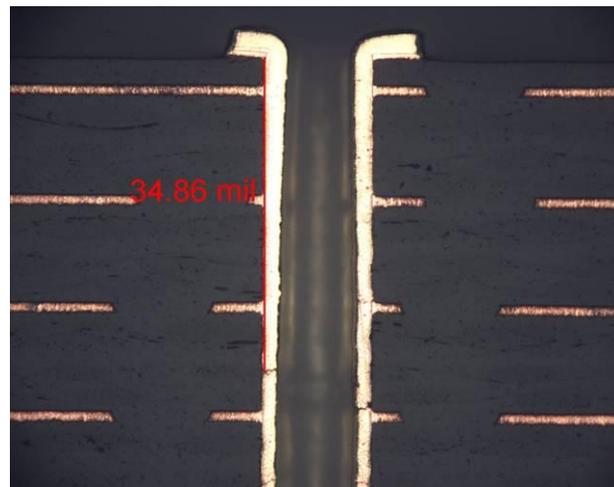
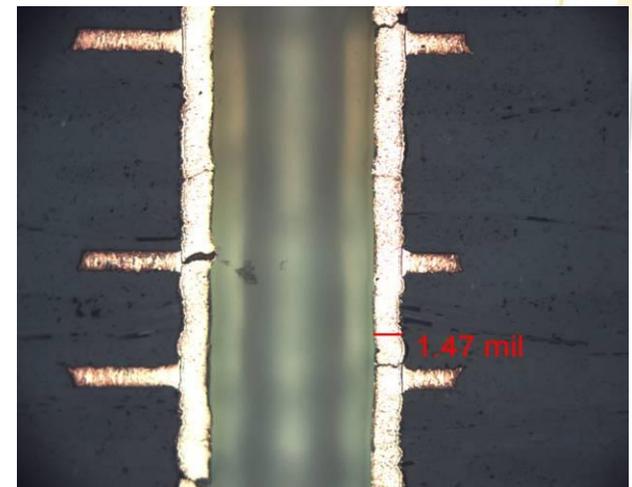
FA – ATC Example (G)

0.8mm pitch (above)
.100" pitch (right)

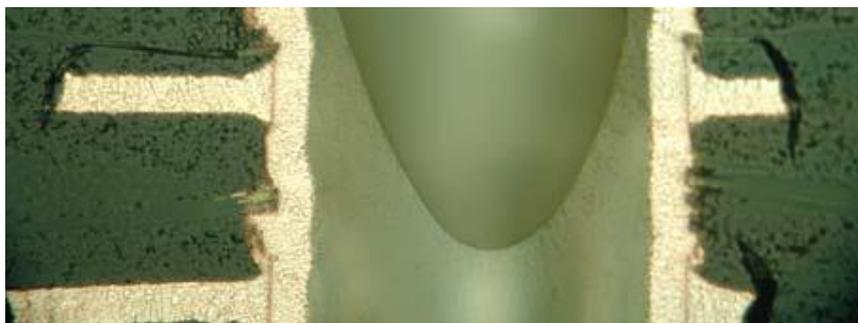
Example of Eyebrow
Cracking
(D)

- Some materials delaminated at 1.00 mm pitch also
 - Eyebrow cracking also found
