Bare Board Material Performance after Pb-Free Reflow

Abstract:

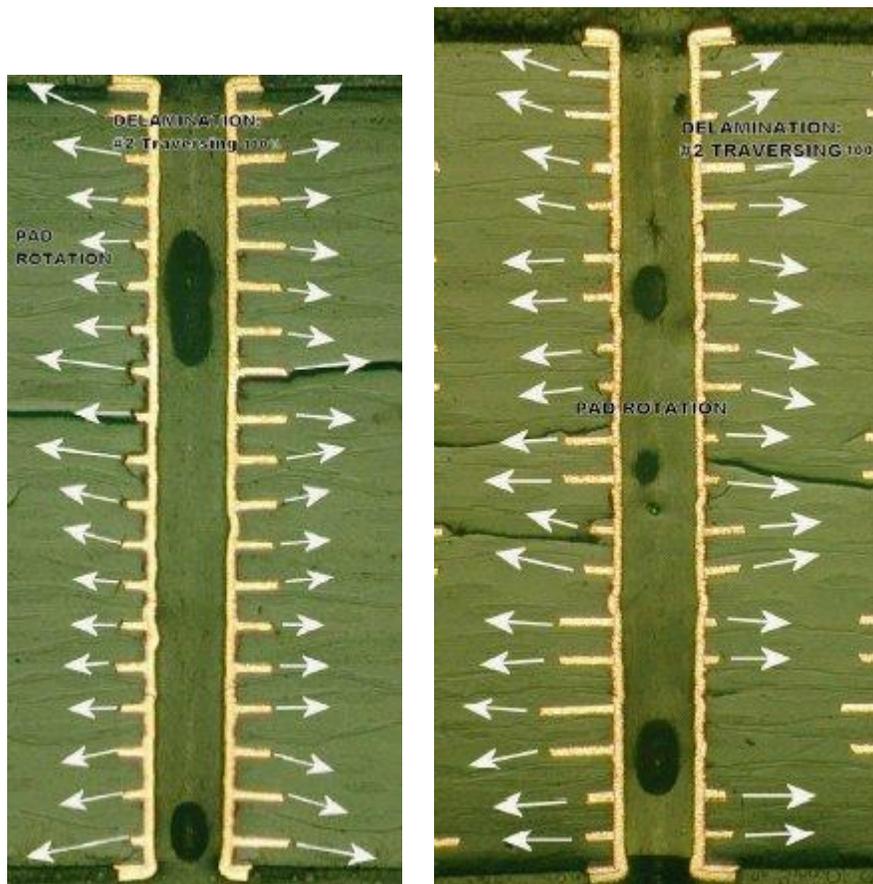
Noted elsewhere in this report (and reported for other testing^{8,9,10}) are examples of reflow simulation appearing to extend the cycles-to-failure of ATC and IST coupons relative to coupons that didn't undergo this preconditioning. Associated with reflow simulation-induced laminate cracking within the test coupon, Bill Birch of PWB Interconnect Solutions has attributed this to stress redistribution. Figure 16 shows examples of vias that experienced more cycles before failure compared with the case for sister coupons that did not experience reflow simulation. The directions of bending of the internal lands suggests that the vias essentially became subdivided into two zones, thereby extending their apparent lifetimes beyond what they would be in the absence of what is surmised (see above) to be otherwise undesirable laminate cracks.

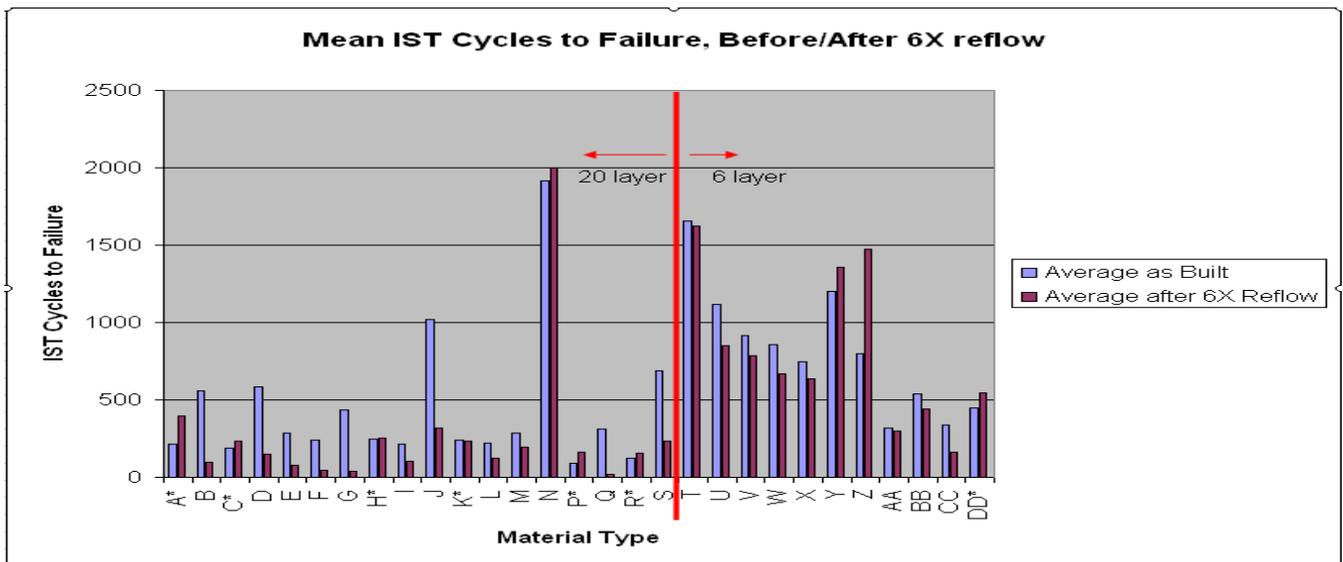
Figure 20: Mean IST Cycles to Failure before and after 6X@260°C Reflow (Asterisks indicate materials that improve after reflow – a probably indication of delamination)

Figure 20 summarizes the IST results as built and after 6X reflow preconditioning for all tested materials Tables 7 and 8 summarize the Weibull and Log Normal analysis of this data before and after reflow respectively.

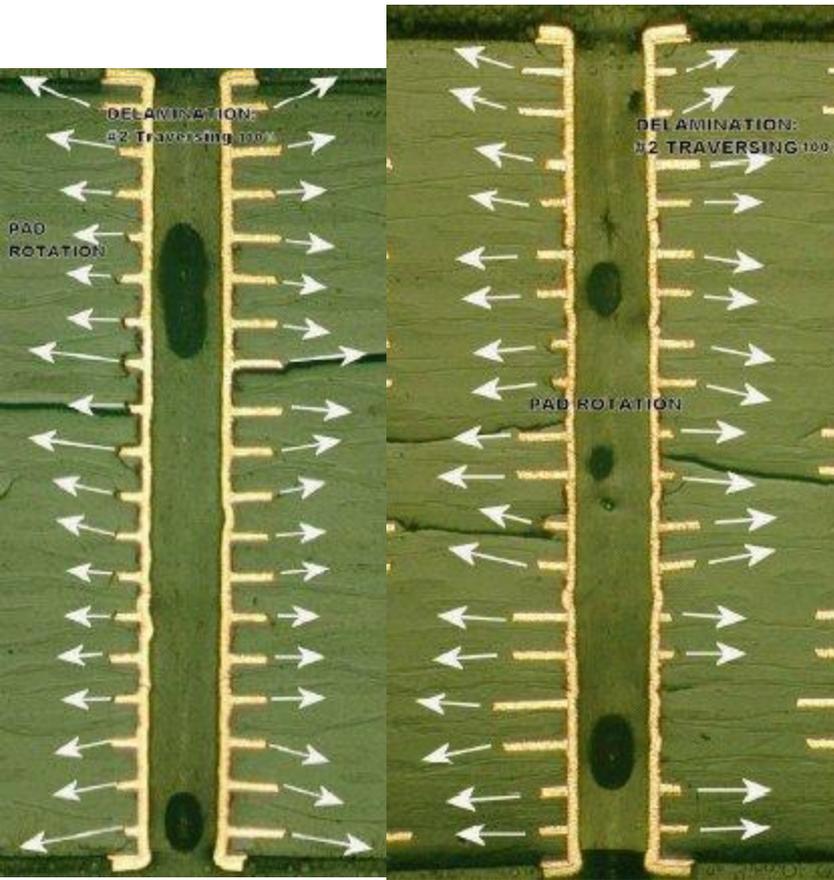
Laminate Integrity Summary

- Performance and Reliability Risks of Internal Delamination/Material Degradation
 - Possible Pathways for CAF
 - Possible Loss of Dielectric Strength
 - Possible Changes in Localized Electrical Properties
 - Reduced Via Integrity
 - False Positive Via Reliability
 - False Positive CAF test performance

- See the paper for details
 - Moisture/volatiles
 - Microfracturing
 - Material Expansion-Stresses
 - Constraints of vias
 - Heat transfer and Moisture Escape paths

- Reduction of entrapped moisture within the laminate
- Use of materials with stronger interfaces
- Use of resins with higher fracture toughness
- Also – Use of materials with lower Z-Axis CTE – reduces stresses from expansion

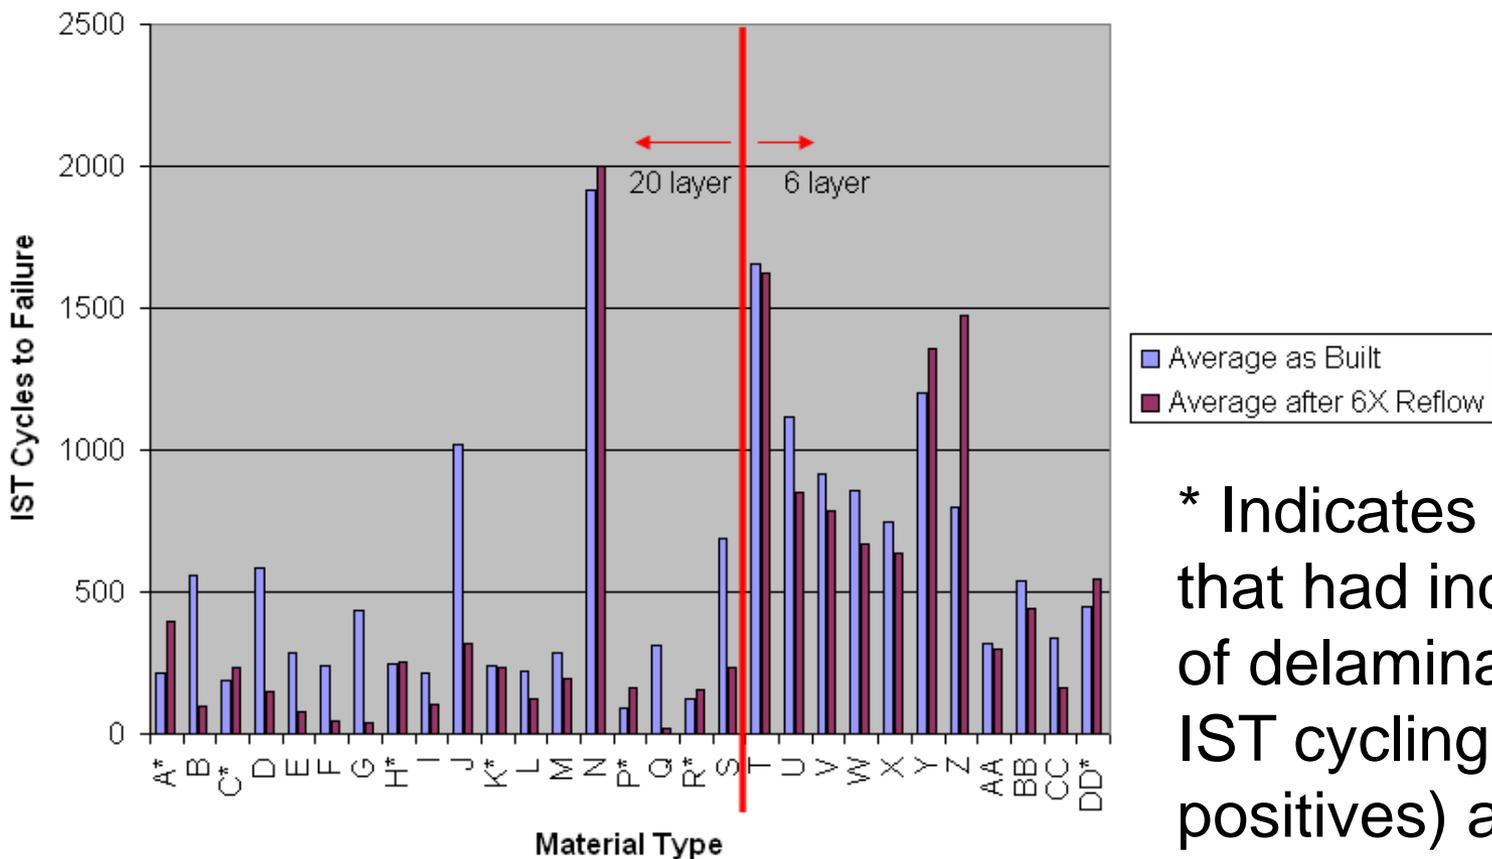
Mean IST Cycles to Failure, Before/After 6X reflow

* Indicates materials that had indication of delamination in IST cycling (false positives) after reflow

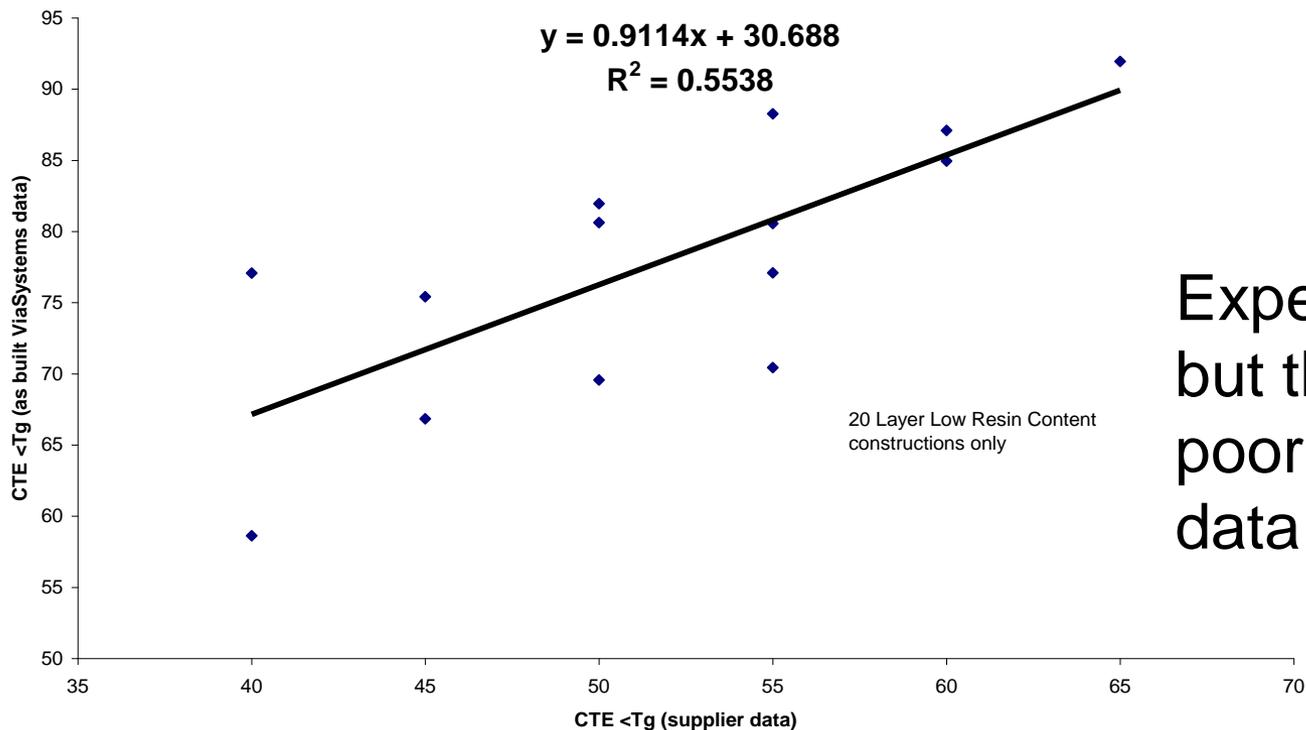
Scatter Chart (CTE <Tg (supplier data) vs CTE <Tg (as built
ViaSystems data))

Expect a difference —
but the correlation is
poor and the fit of the
data is terrible

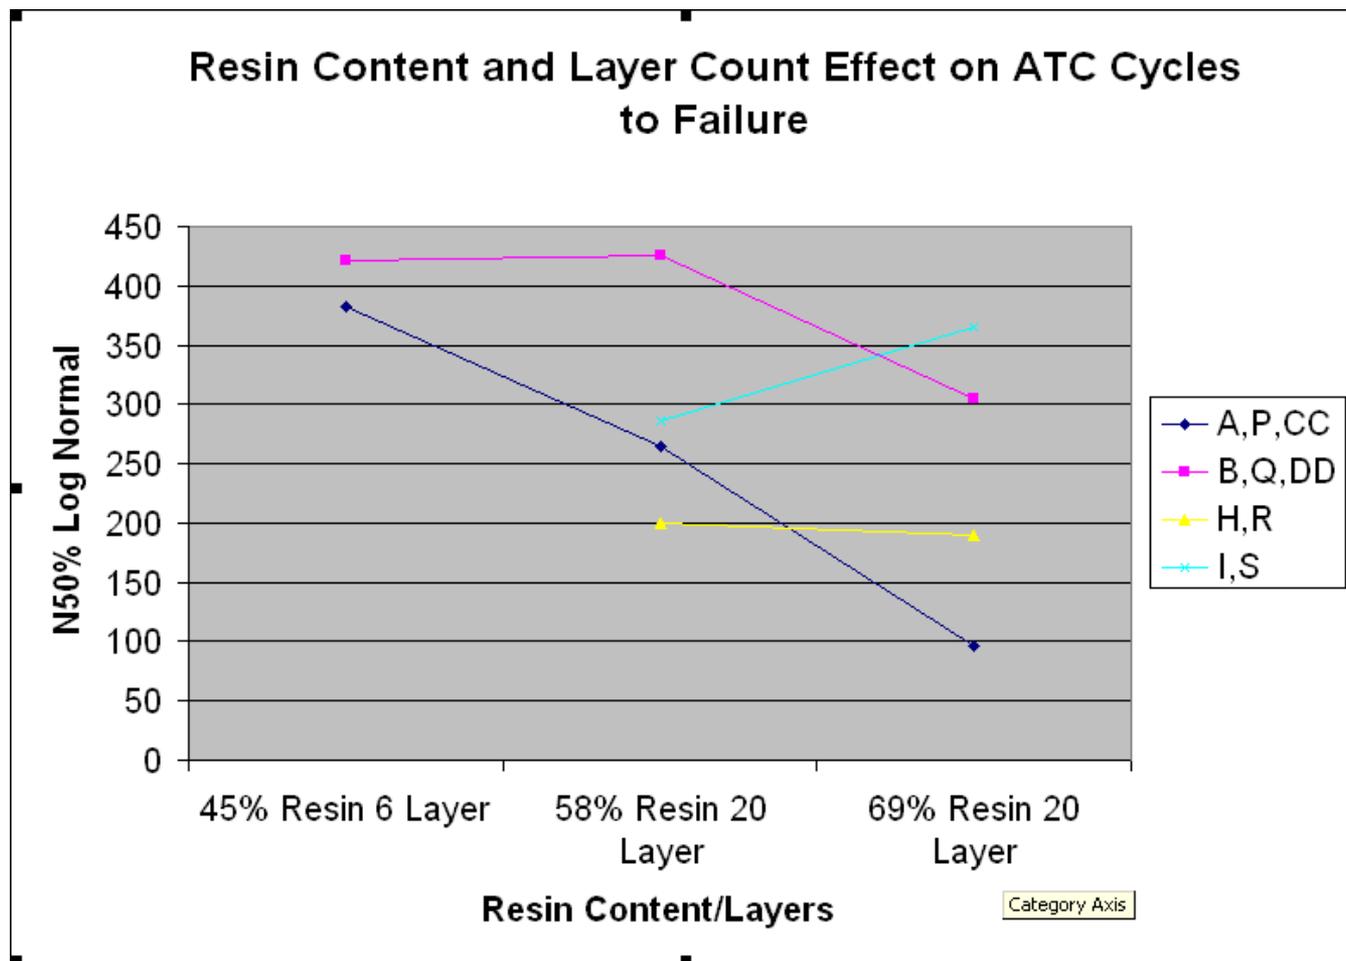
Resin Content and Layer Count Effect on ATC

Primary effect is Resin Content – directly linked to Z-CTE
Layer count is a secondary affect
