# Bridging Supply Chain Gap for Exempt High-Reliability OEM's

Hal Rotchadl  
[hrotchadl@premiers2.com](mailto:hrotchadl@premiers2.com)  
[www.premiers2.com](http://www.premiers2.com)  
Premier Semiconductor Services  
Tempe, AZ

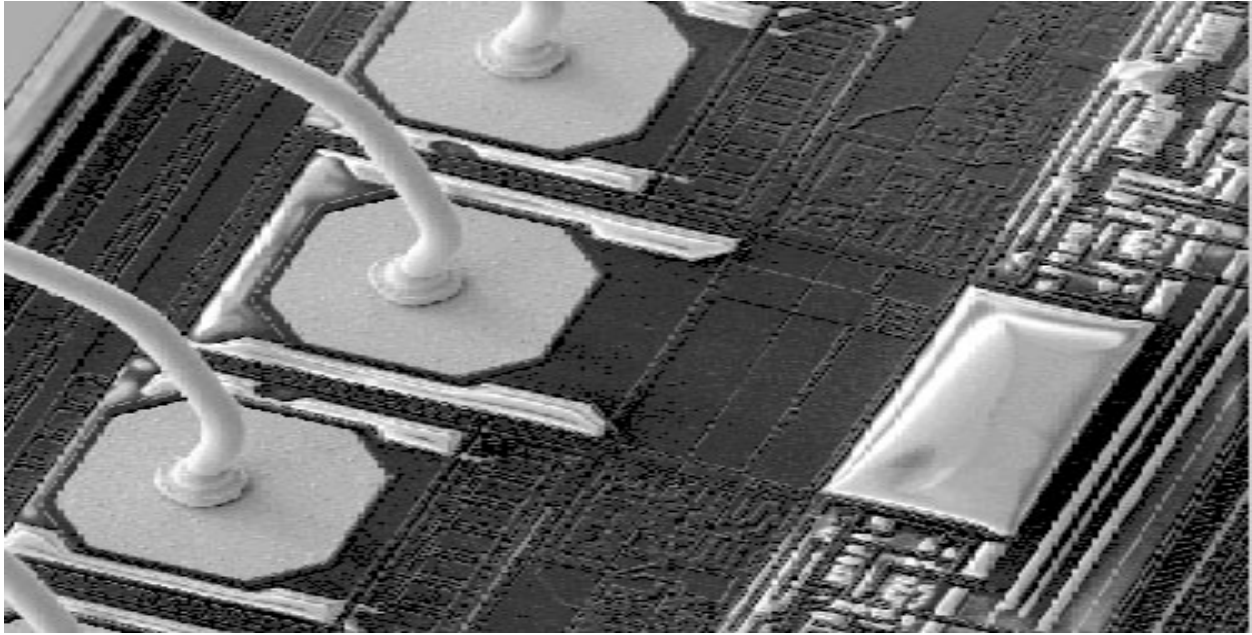
Figure 1 Wire Bond Device

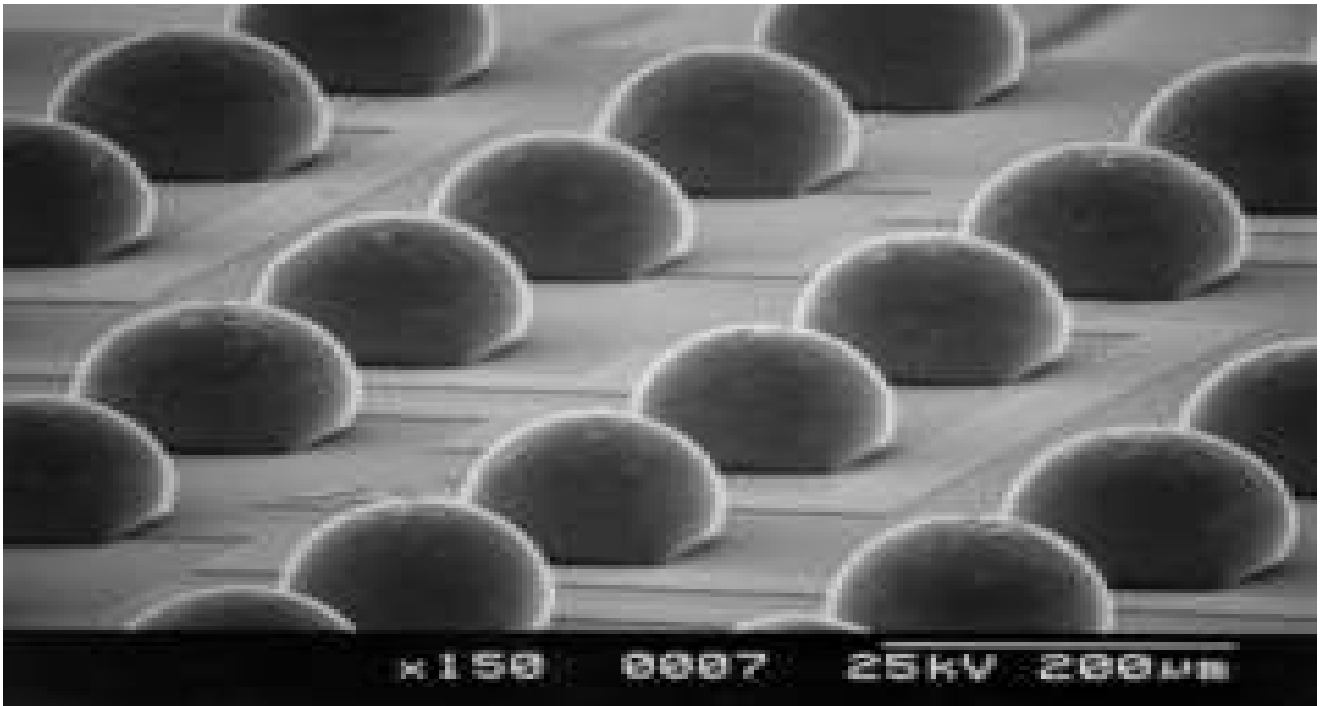
Figure 2 Flip Chip Device

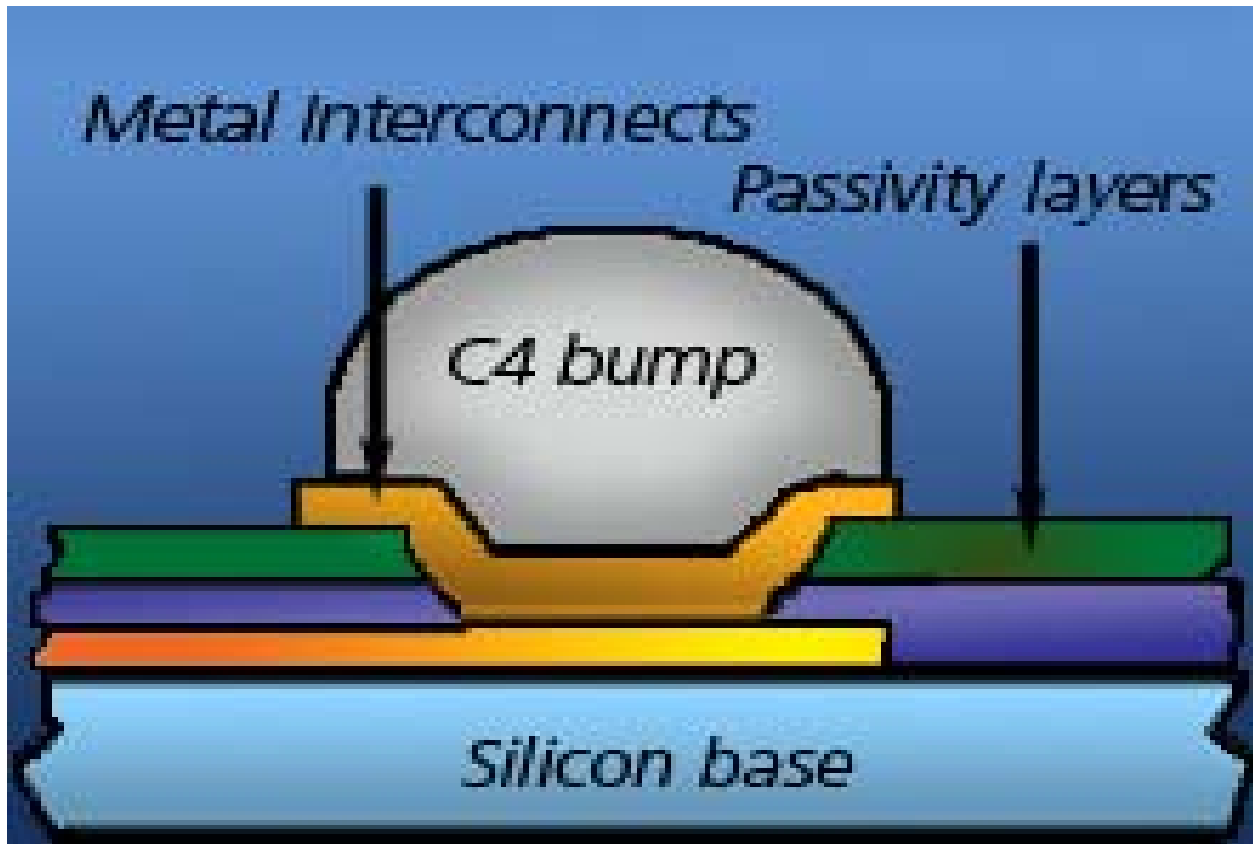
Figure 3 Flip Chip Bump Construction

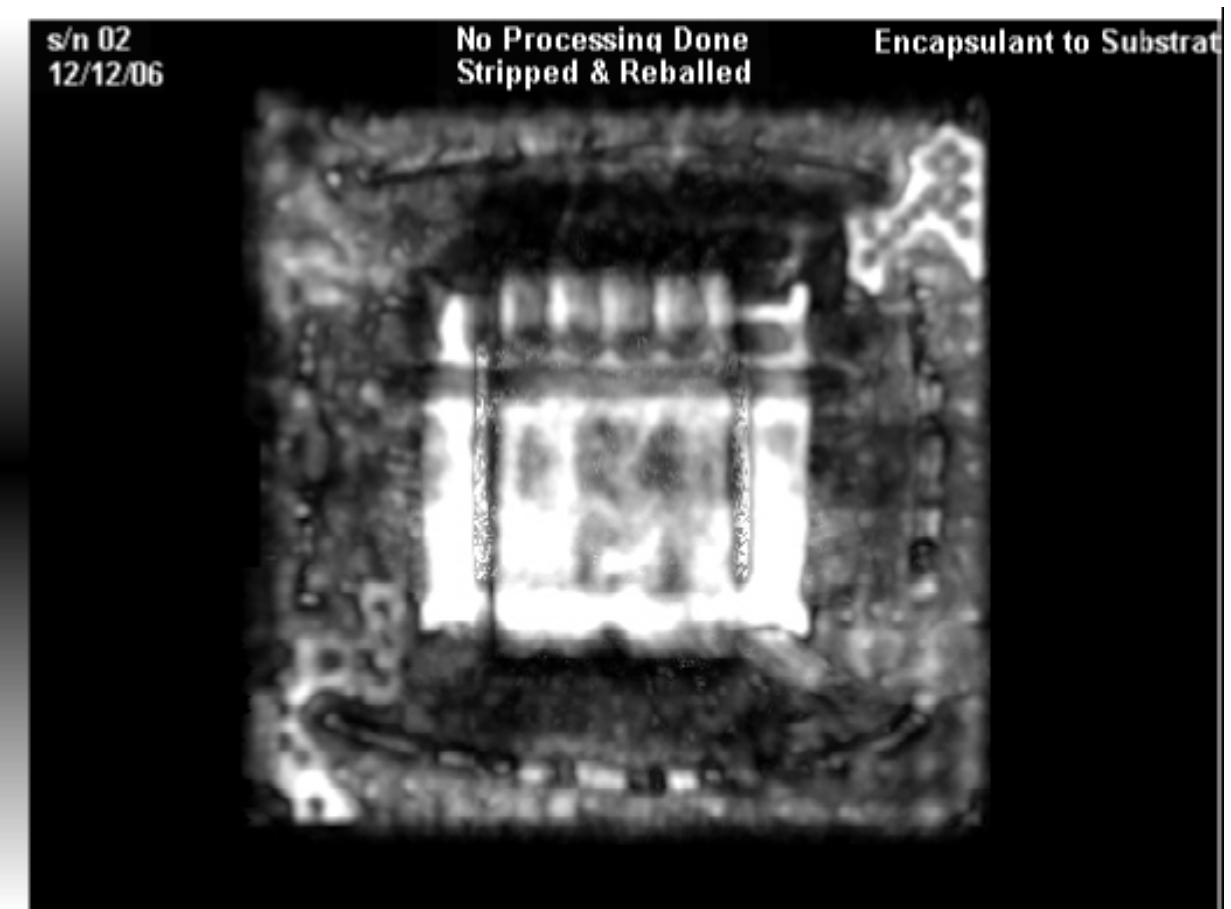
Figure 4 Encapsulation to Substrate

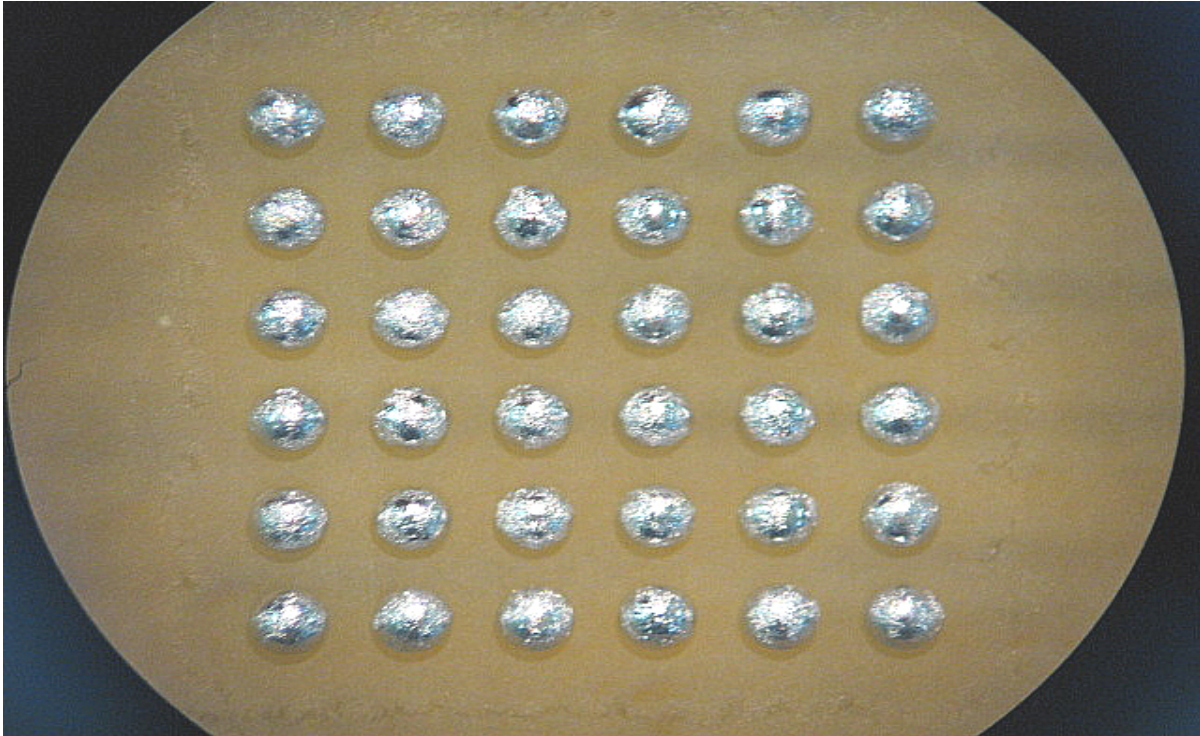
**Figure 5 BGA with Pb Free Spheres**

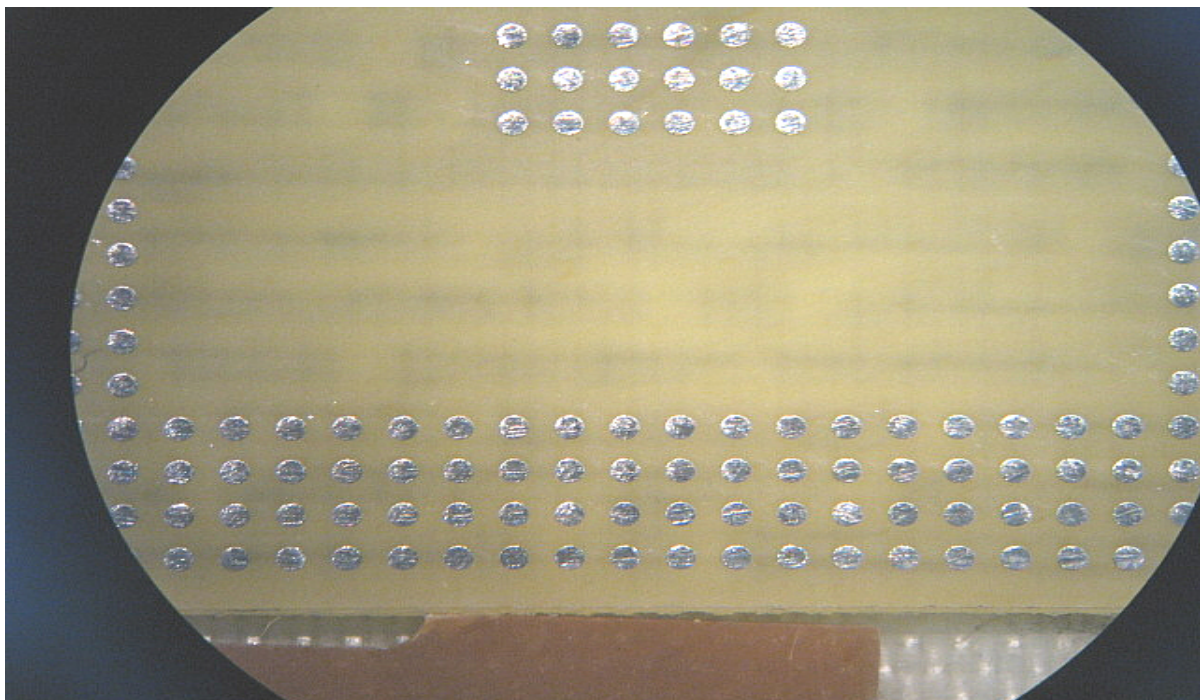
**Figure 5 BGA with Pb Free Stripped Spheres**

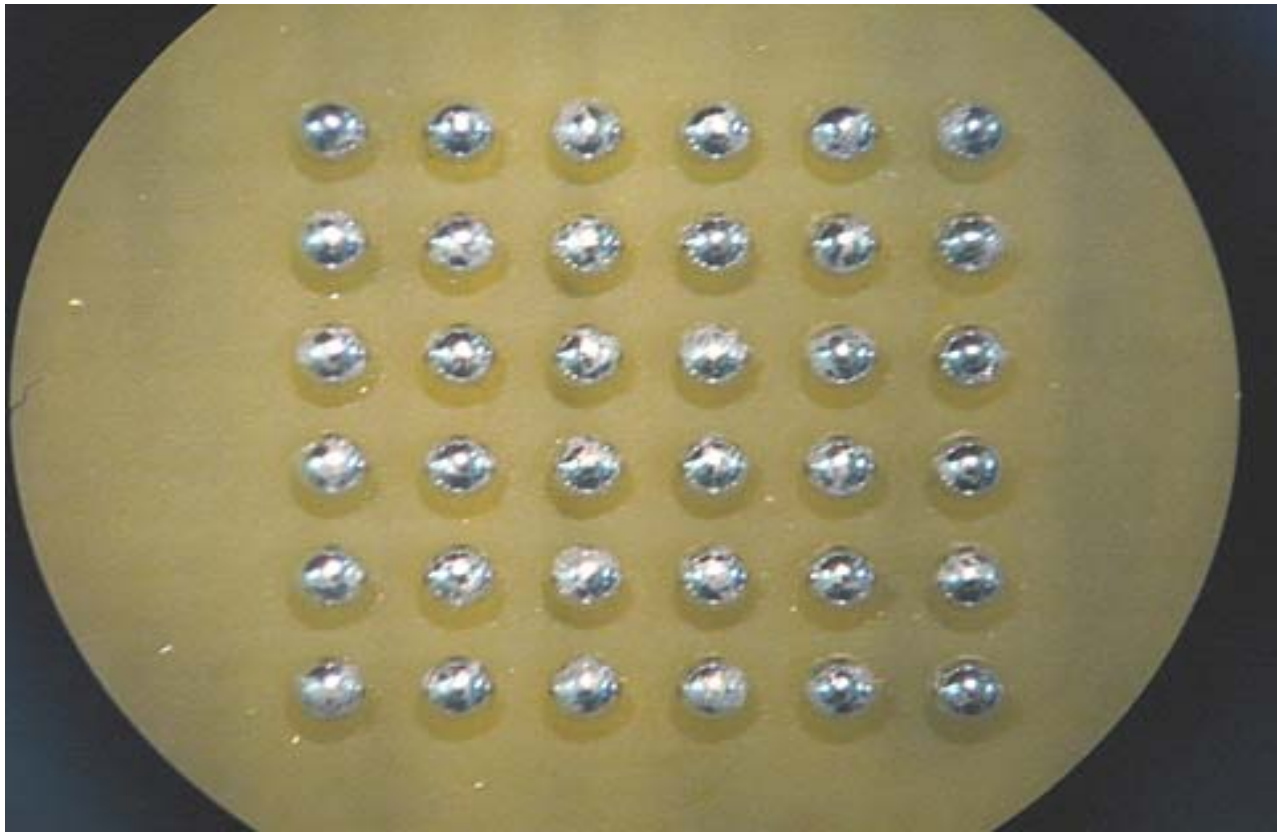
**Figure 6 Attached Spheres**

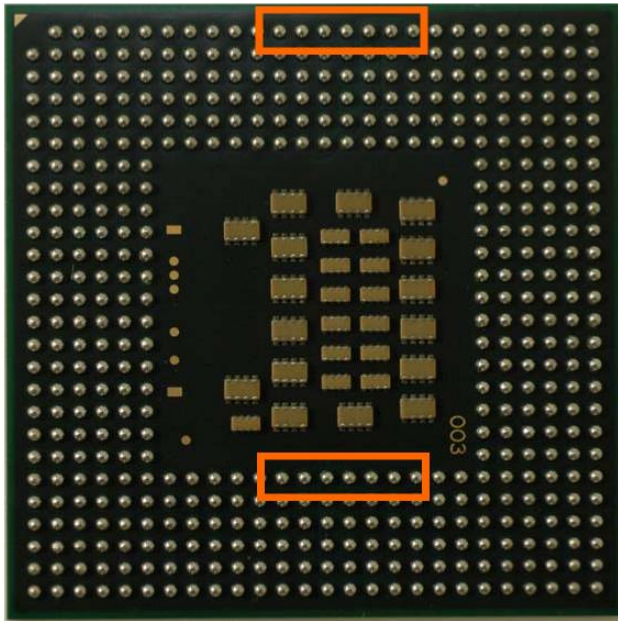
**Figure 7 Shear Test (0.6mm Sphere)**

Ball Dia.	Test #	Force (g)	Description	Platform	Load Cell
0.3mm	1	241.58	Pass	Dage 4000	BS5Kg
0.3mm	2	237.18	Pass	Dage 4000	BS5Kg
0.3mm	3	230.50	Pass	Dage 4000	BS5Kg
0.3mm	4	238.53	Pass	Dage 4000	BS5Kg
0.3mm	5	235.77	Pass	Dage 4000	BS5Kg
0.6mm	1	1538	Pass	Dage 2400	BS2Kg
0.6mm	2	1480	Pass	Dage 2400	BS2Kg
0.6mm	3	1701	Pass	Dage 2400	BS2Kg
0.6mm	4	1591	Pass	Dage 2400	BS2Kg
0.6mm	5	1427	Pass	Dage 2400	BS2Kg

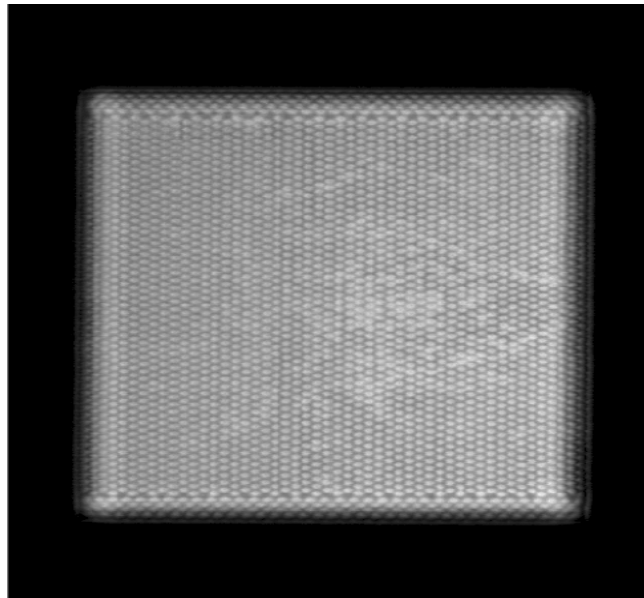
**Figure 8 FC die/underfil interface showing no delaminations from Substrate**

Twenty four (24) of the forty one (41) packages were subjected to CSAM analysis. The purpose of this evaluation is to make sure that multiple re-flow temperature profiles subjected to the packages during the lead free ball removal and the subsequent re-balling process did not initiate or cause underfil delaminations at the flip chip die interface.

This type of evaluation is normally recommended to be performed when Flip Chip (FC) packages are exposed to temperature excursion or profiles. Underfil delaminations can either failures or compromise the integrity and reliability of the package solder bump interconnects.

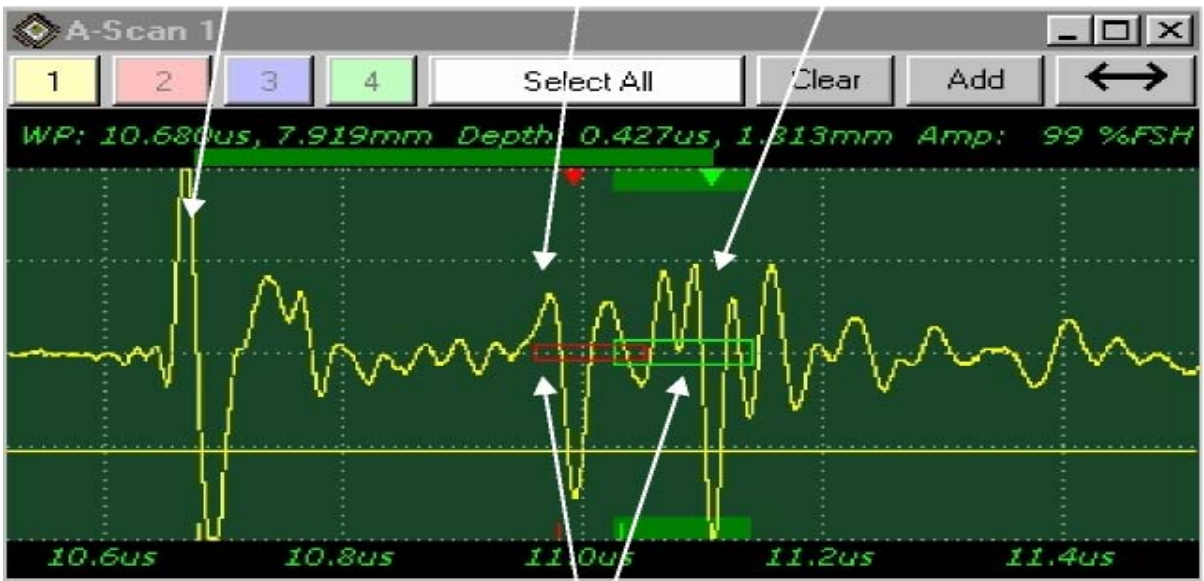
Figure 9 Example of an Acoustic Transducer Response with response gates at special package interfaces of interest

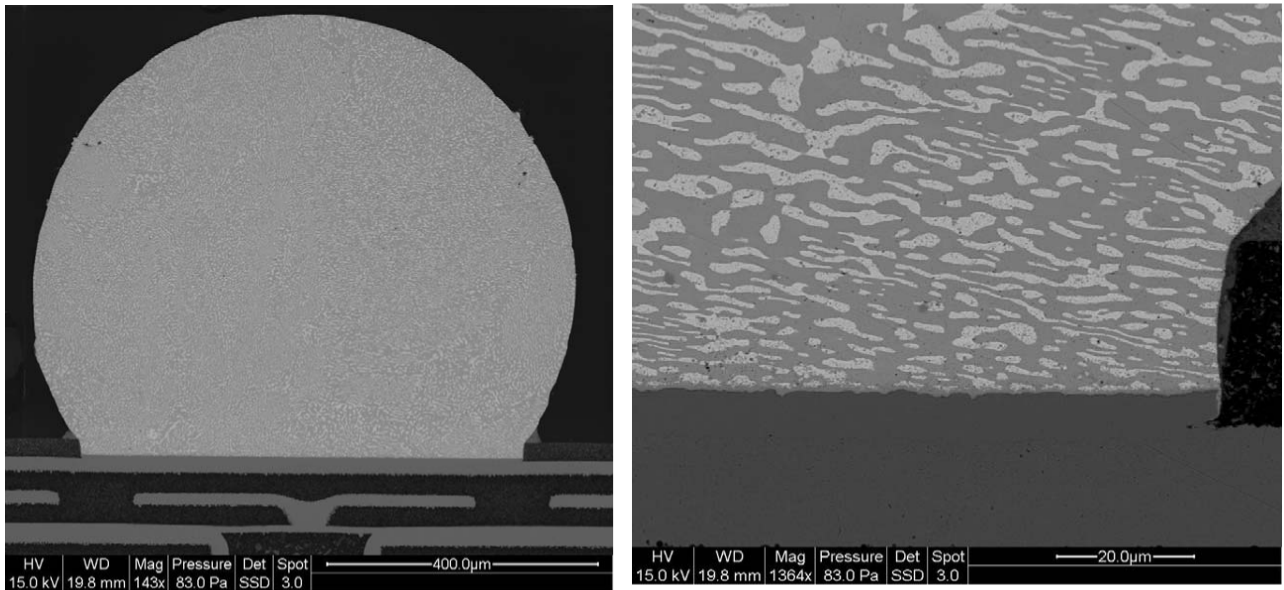
Figure 10 SEM Inspection of Solder Joint

- X-ray inspection showed no voiding
- Cross sections showed good metallurgical ball attachment
- CSAM analysis - no FC/underfil interface delamination
- Extensive solder ball shear performed showed good BGA to substrate solder joints with tight shear force range all above the industry acceptable level. The shear failure was always in the bulk solder indicating strong solder joint to the substrate pads.

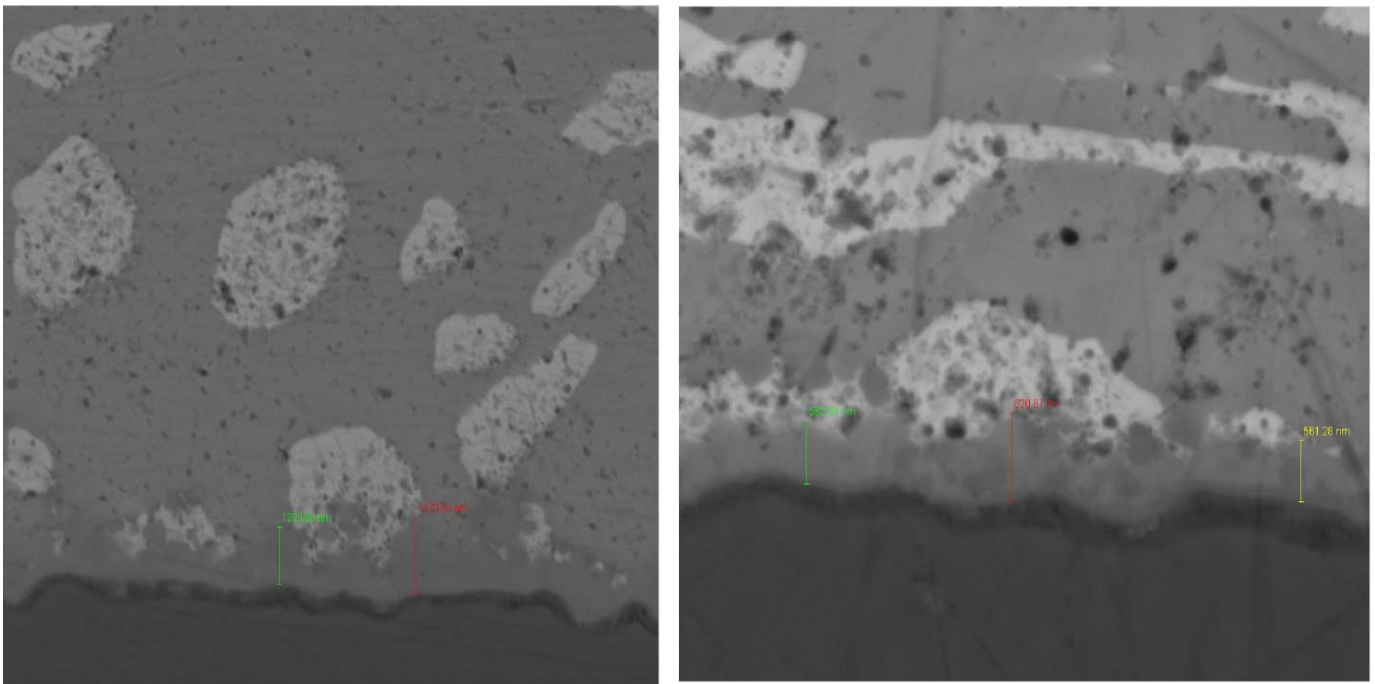
**Figure 11 Intermetallic Region**

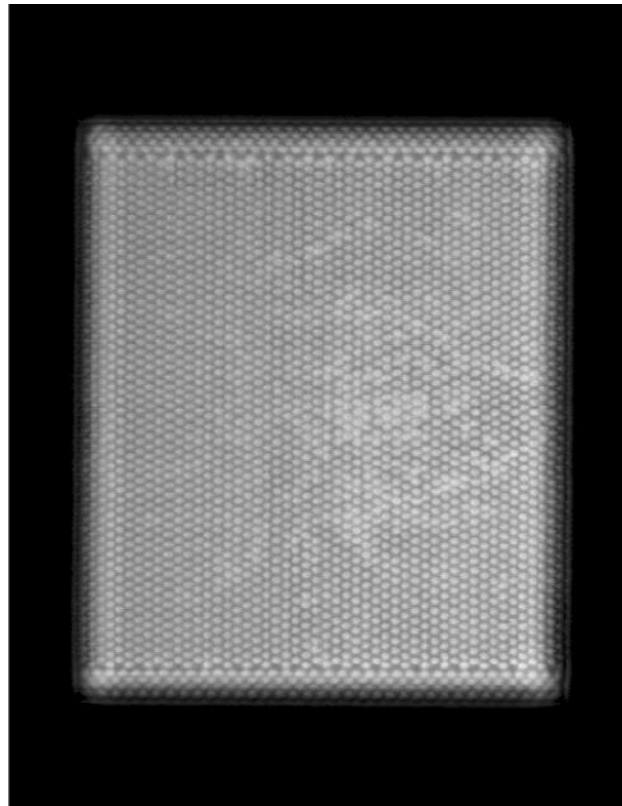
# C-SAM of Flip Chip Bumps

**FC die/underfil interface showing no delaminations from Substrate**

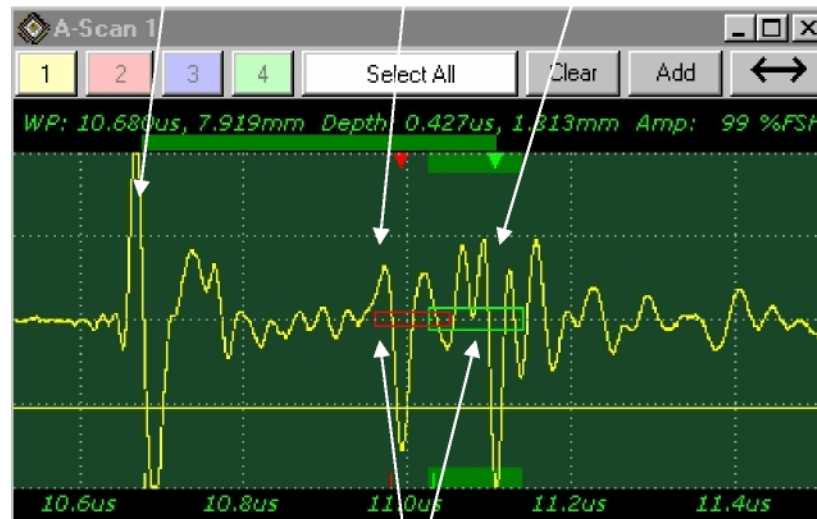
# Acoustic Analysis Chart

Example of an **Acoustic Transducer Response** with response gates at special package interfaces of interest.

Twenty four (24) of the forty one (41) packages were subjected to CSAM analysis. The purpose of this evaluation is to make sure that multiple re-flow temperature profiles subjected to the packages during the lead free ball removal and the subsequent re-balling process did not initiate or cause underfil delaminations at the flip chip die interface.

## Illustration of Acoustic Transducer Response Chart

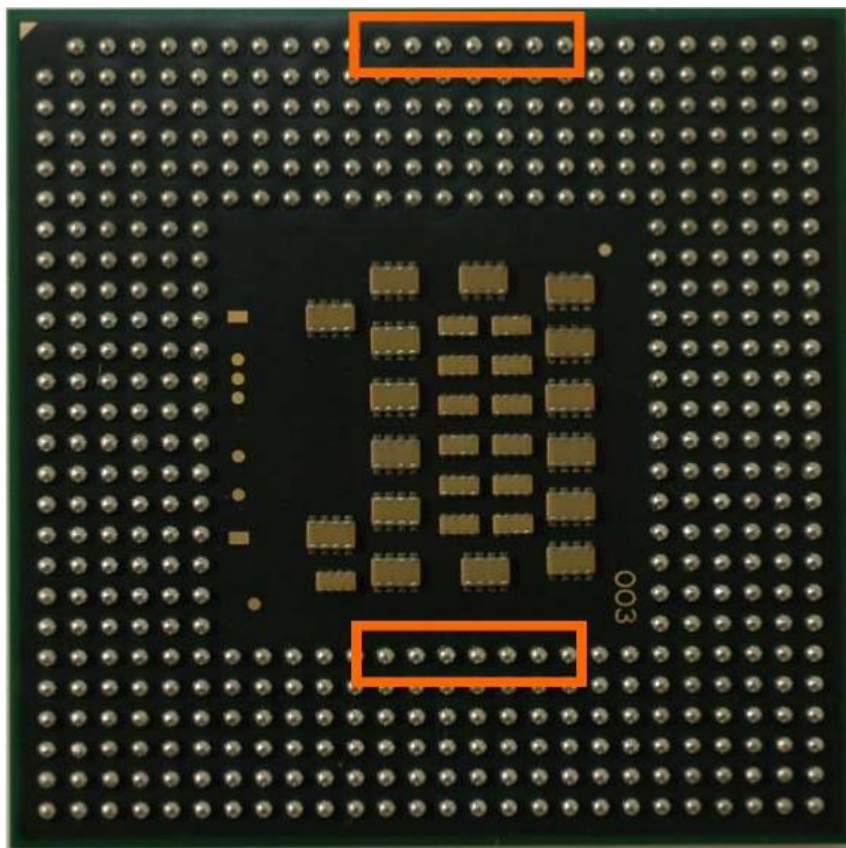
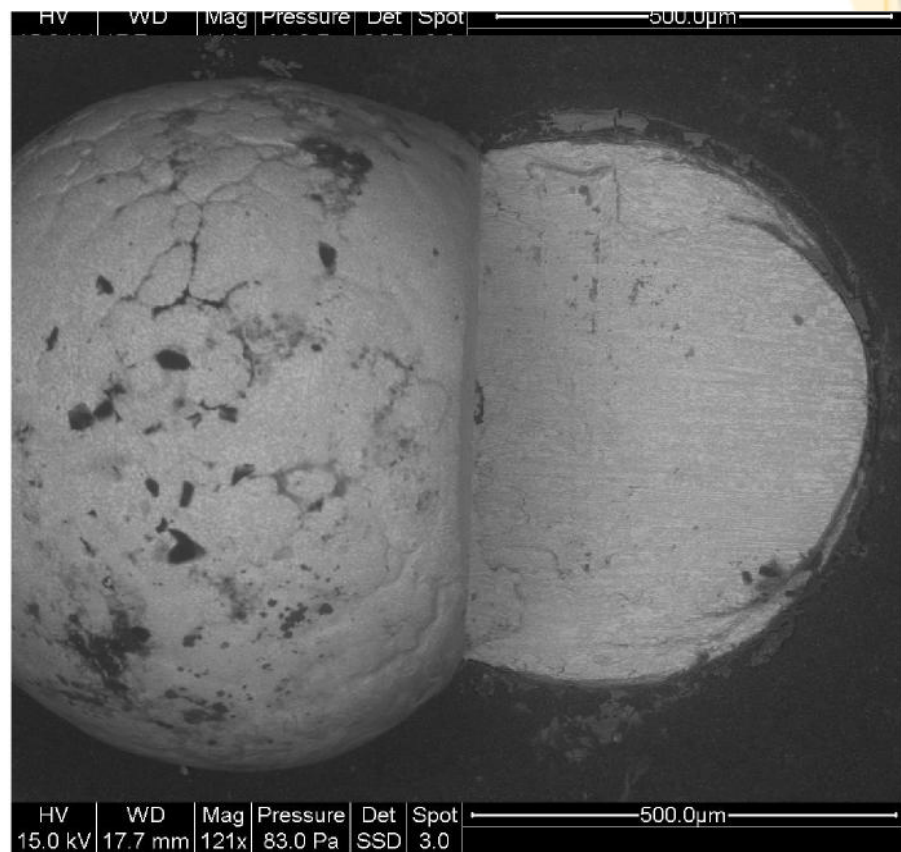
# 0.6mm Ball Shear

Ball Dia.	Test #	Force (g)	Description	Platform	Load Cell
0.3mm	1	241.58	Pass	Dage 4000	BS5Kg
0.3mm	2	237.18	Pass	Dage 4000	BS5Kg
0.3mm	3	230.50	Pass	Dage 4000	BS5Kg
0.3mm	4	238.53	Pass	Dage 4000	BS5Kg
0.3mm	5	235.77	Pass	Dage 4000	BS5Kg
<b>0.6mm</b>	<b>1</b>	<b>1538</b>	<b>Pass</b>	<b>Dage 2400</b>	<b>BS2Kg</b>
<b>0.6mm</b>	<b>2</b>	<b>1480</b>	<b>Pass</b>	<b>Dage 2400</b>	<b>BS2Kg</b>
<b>0.6mm</b>	<b>3</b>	<b>1701</b>	<b>Pass</b>	<b>Dage 2400</b>	<b>BS2Kg</b>
<b>0.6mm</b>	<b>4</b>	<b>1591</b>	<b>Pass</b>	<b>Dage 2400</b>	<b>BS2Kg</b>
<b>0.6mm</b>	<b>5</b>	<b>1427</b>	<b>Pass</b>	<b>Dage 2400</b>	<b>BS2Kg</b>
